L1358070001 – Montgomery
Eagle Zinc Company
ILD 980606941
SF/HRS

Expanded Site Inspection

CERCLA Expanded Site Inspection Report
for

Eagle Zinc Company

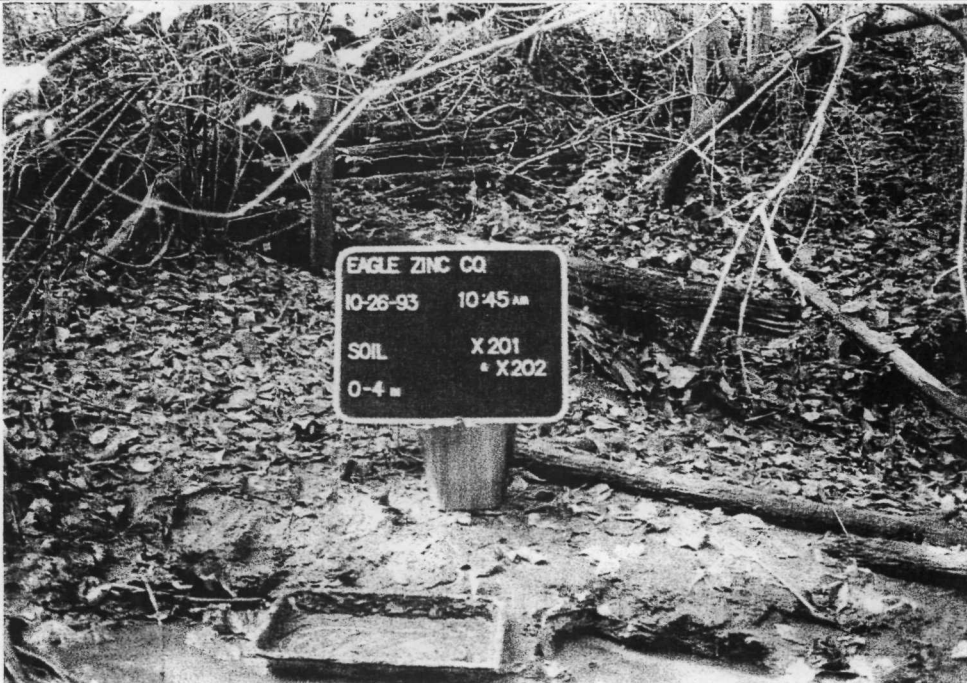
Samples X201, and duplicate sample X202, were collected from the intermittent stream west of Eagle Zinc (Figure 3-2). These two samples served to provide background concentration information for all sediment samples collected during the Expanded Site Inspection. Samples X201 and X202, were located upstream of X203 and therefore believed not to be affected by surface drainage from the Eagle Zinc property. The sample was taken from the west bank of the stream at the confluence of the two intermittent streams. Sediments were collected from approximately zero to four inches by use of a stainless steel trowel. Prior to collecting this sample, sediments were placed in a stainless steel tray and mixed thoroughly using a trowel.

COMMENTS: Picture taken toward: WEST	
Sample X201\X202	
(DUP. of X201)	
Background sediment sample.	
Roll 1, Photo 7	
Depth 0-4 in

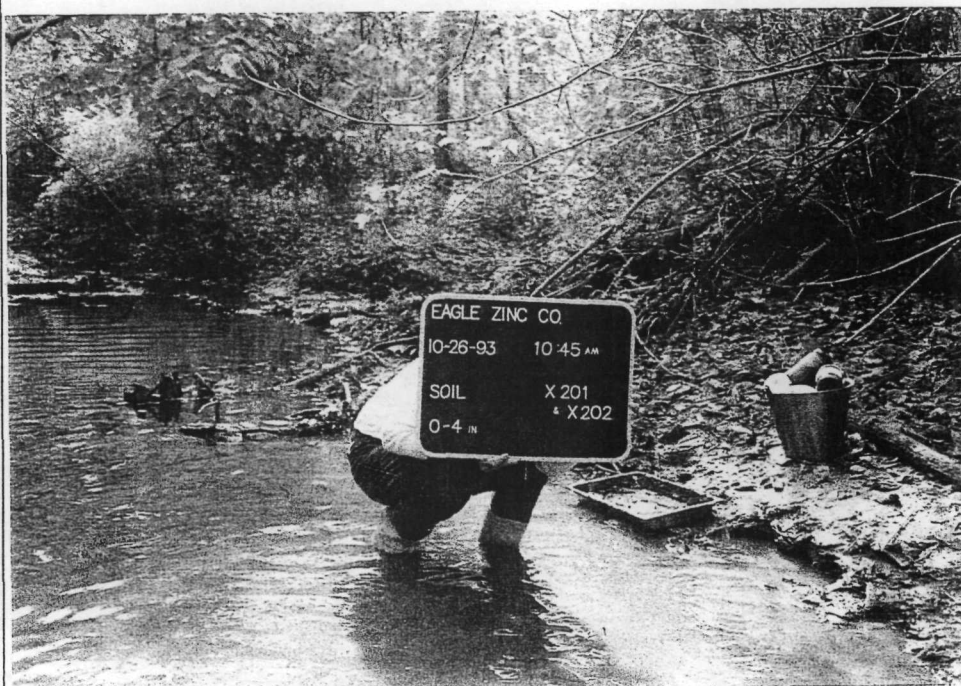
DATE: 10/26/93
TIME: 10:45 A
PHOTOGRAPH TAKEN BY: BRUCE EVERETTS
COMMENTS: Picture taken toward: SOUTH
SAMPLE X201\X202
(DUP. of X201).
Background sediment sample.
Depth 0-4 in
Roll 1, Photo 8

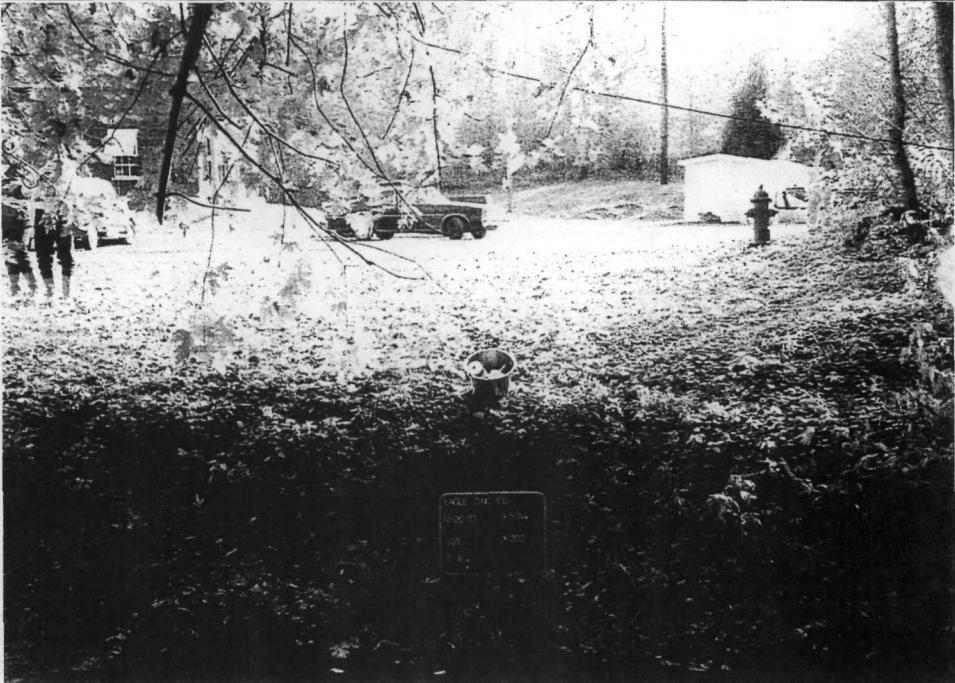
Sample X203 was collected from the intermittent stream, upstream from sampling point X204, near Hillsboro's water treatment plant. The sample was taken from the east bank of the stream in an area of sediment deposition. The purpose of collecting this sample was to determine whether contaminants have migrated downstream from the facility. Sediment was collected using a stainless steel hand trowel at a depth of 0-4 inches.

COMMENTS: Picture taken toward: NORTHEAST	
SAMPLE X203	
Sediment sample.	
Hillsboro Water	
Plant in the back-ground.	
Roll 1, Photo 5	
Depth 0-4 in

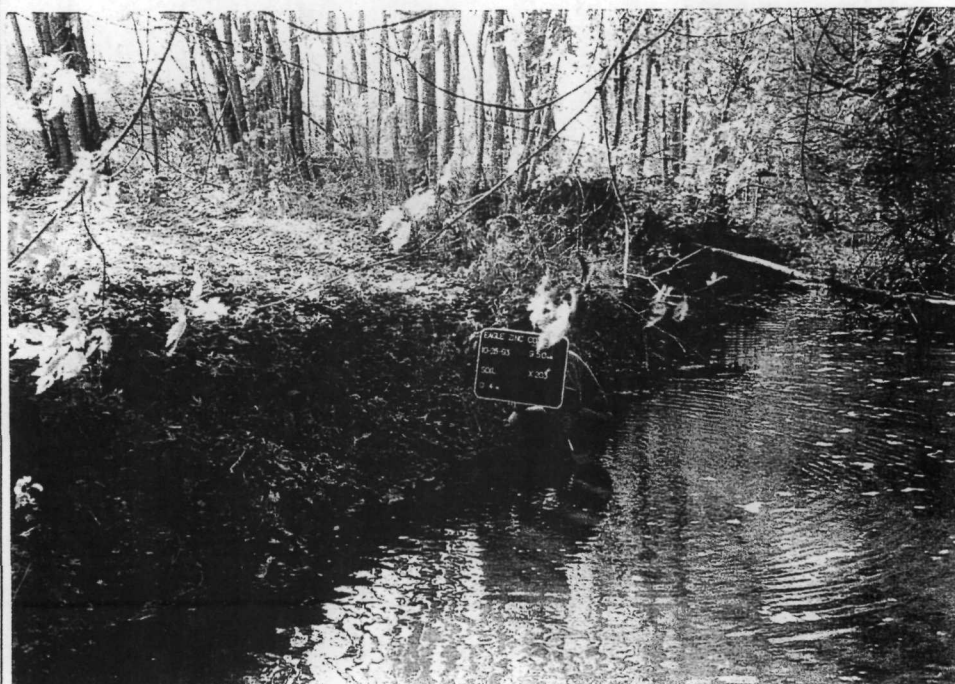
DATE: 10/26/93
TIME: 9:50 A
PHOTOGRAPH TAKEN BY: MARK WAGNER
COMMENTS: Picture taken toward: SOUTH
SAMPLE X203
Sediment sample.
Depth 0-4 in
Roll 1, Photo 6

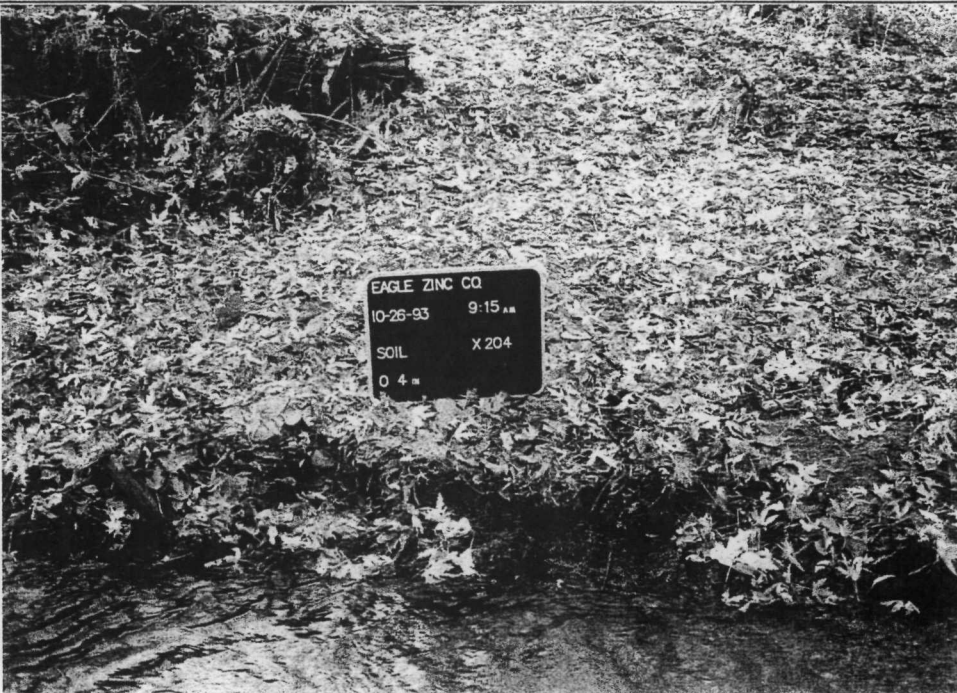
COMMENTS: Picture taken toward: SOUTHEAST	
Sample X 204	
Sediment sample.	
Depth 0-4 in	
Roll 1, Photo 3

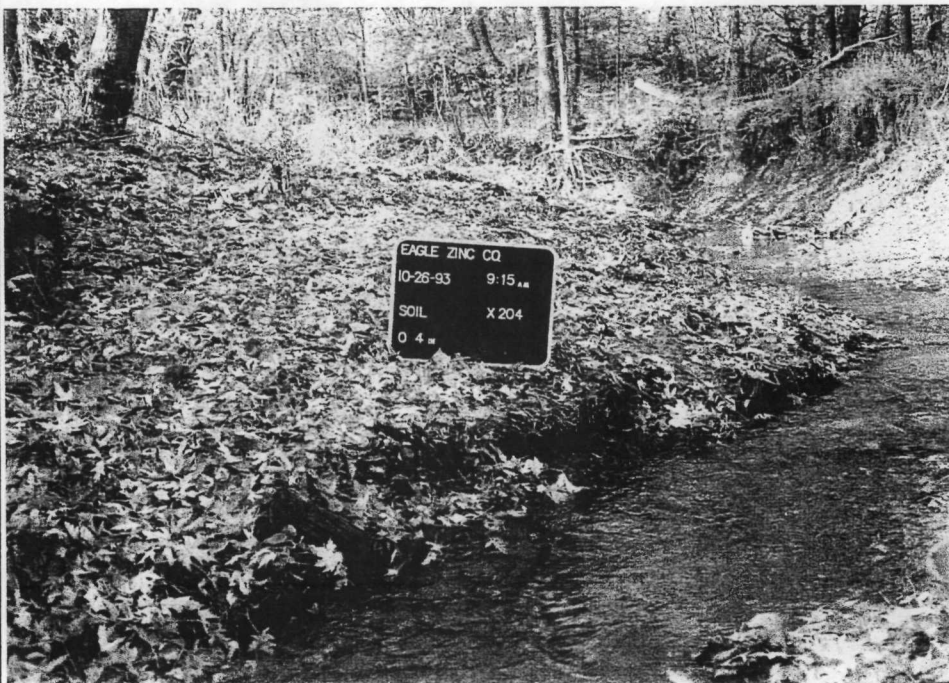
DATE: 10/26/93
TIME: 9:15 A
PHOTOGRAPH TAKEN BY: MARK WAGNER
COMMENTS: Picture taken toward: SOUTH
Sample X 204
Sediment sample.
Depth 0-4 in
Roll 1, Photo 4

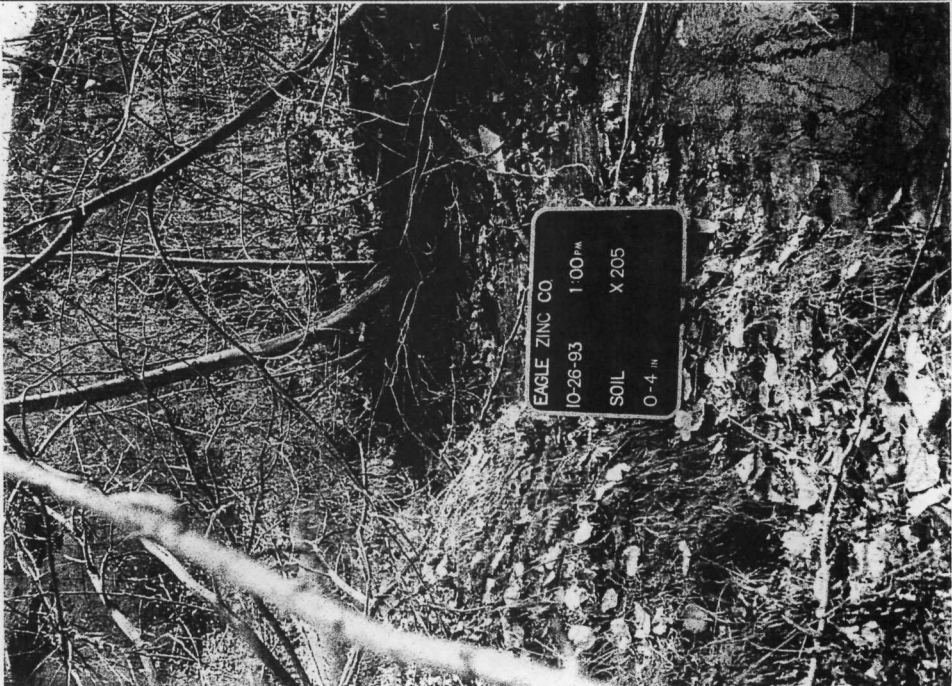
Sample X205 was collected from the surface drainage route on the west side of Eagle Zinc property. The sediment sample was collected immediately downstream of the retention pond located on the facility. A sample of the sediments were collected using a stainless steel trowel at a depth of 0-4 inches. Flow of the stream at the time the sample was taken was low. The purpose of this sample was to determine if hazardous substances had migrated from the facility, along the intermittent stream.

COMMENTS: Picture taken toward: SOUTHEAST	
Sample X205	
Eagle Zinc Co.	
residue pile in background, sample was collected off-site. Depth 0-4 in	
Roll 1, Photo 11

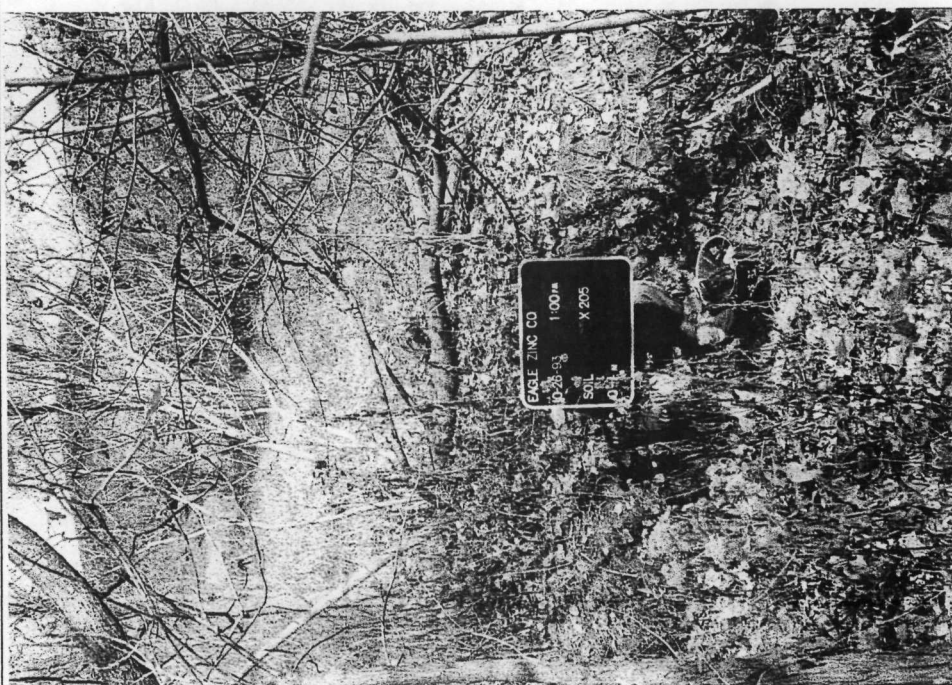
DATE: 10/26/93
TIME: 1:00 P
PHOTOGRAPH TAKEN BY: MARK WAGNER
COMMENTS: Picture taken toward: NORTHEAST
Sample X 205
Sediment sample.
Zinc residue pile in background.
Depth 0-4 in
Roll 1, Photo 12

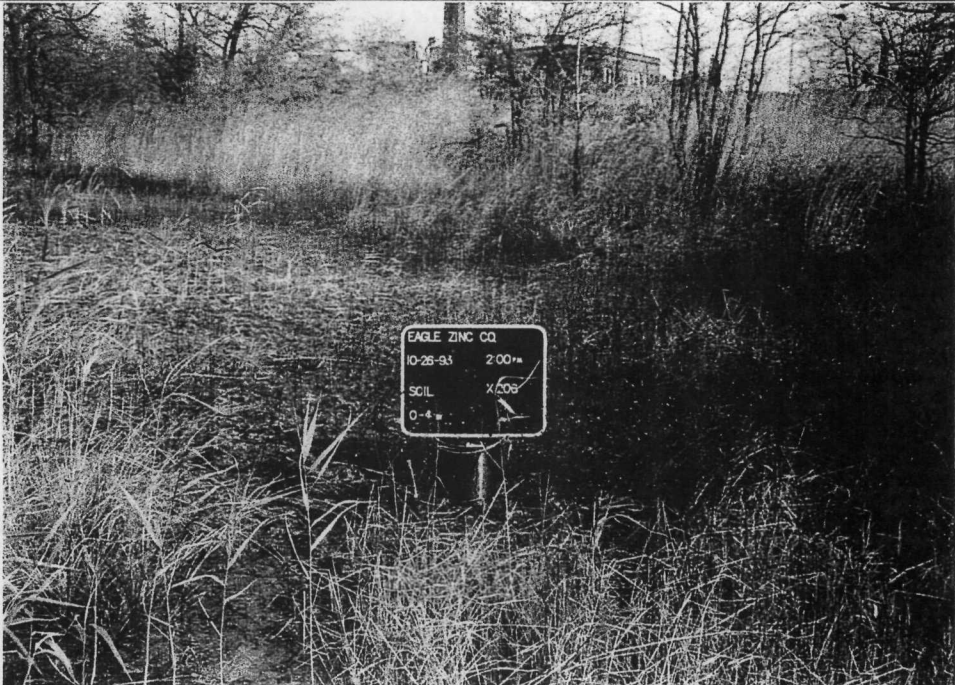
Sample X206 was the final sediment sample collected. The sample was located in the surface water drainage route, directly west of the zinc facility. The area west of the plant, slopes toward the southwest corner of the property where the pond is located (Appendix I). Surface runoff from around the facility and residue deposited throughout the site may have migrated toward this area due to sloping topography. X206 was collected before sediments reached the facility pond. Sediments were collected using a stainless steel hand trowel at a depth of 0-4 inches. Purpose of this sample was to determine whether contaminants had migrated toward the facility pond.

COMMENTS: Picture taken toward: NORTHEAST	
Sample X 206	
Sediment sample.	
Eagle Zinc Co. in the background.	
Depth 0-4 in	
Roll 2, Photo 1

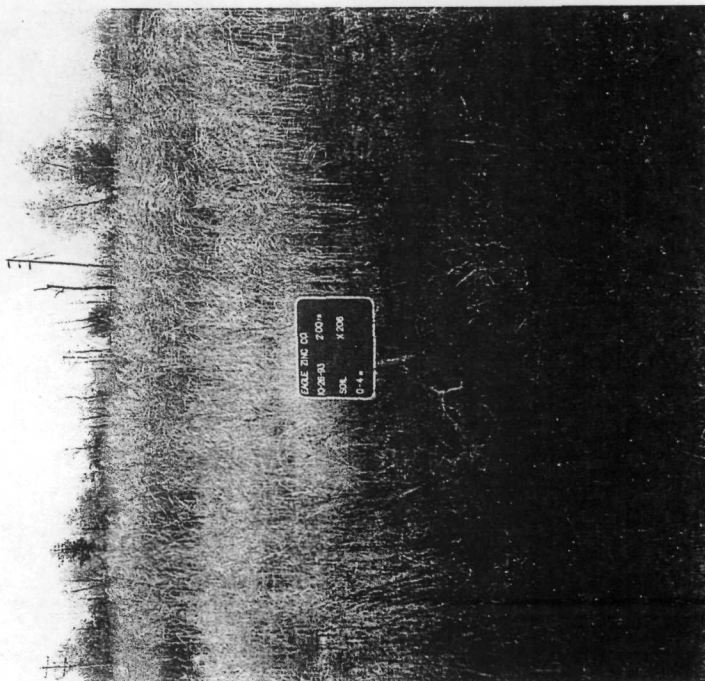
DATE: 10/26/93
TIME: 2:00 P
PHOTOGRAPH TAKEN BY: MARK WAGNER
COMMENTS: Picture taken toward: NORTHWEST
Sample X 206
Sediment sample in swampy area before on-site pond.
Depth 0-4 in
Roll 2, Photo 2

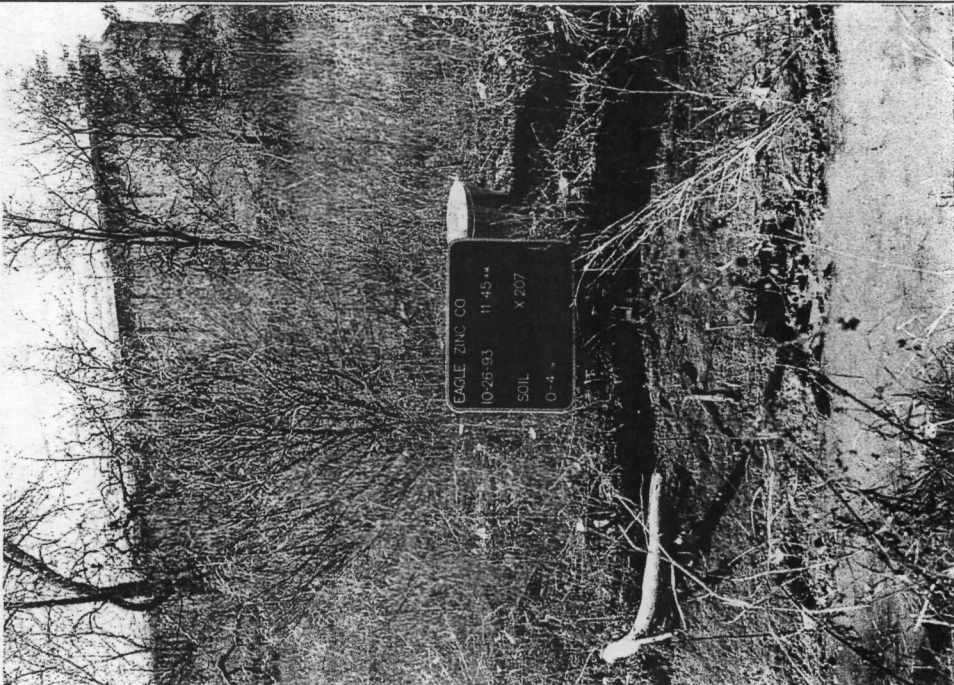
Sample X207 was collected from the stream north of Eagle Zinc. The sample was located in the streambed 70 feet west of Industrial Drive, which runs North-South on the east side of Eagle Zinc property. Sediments were collected using a stainless steel hand

COMMENTS: Picture taken toward: SOUTHWEST	
Sample X 207	
Sediment sample	
from stream drain-	
north end of site.	
Eagle Zinc in back.	
Depth 0-4 in	
Roll 1, Photo 9

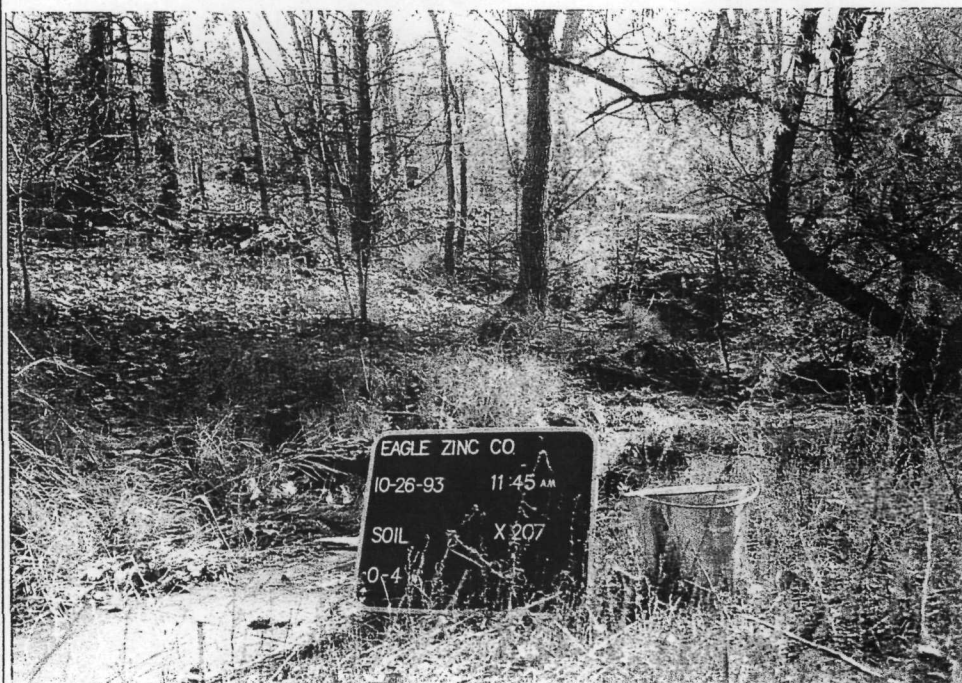
DATE: 10/26/93
TIME: 11:45 A
PHOTOGRAPH TAKEN BY: MARK WAGNER
COMMENTS: Picture taken toward: EAST
Sample X 207
Sediment sample.
Depth 0-4 in
Roll 1, Photo 10

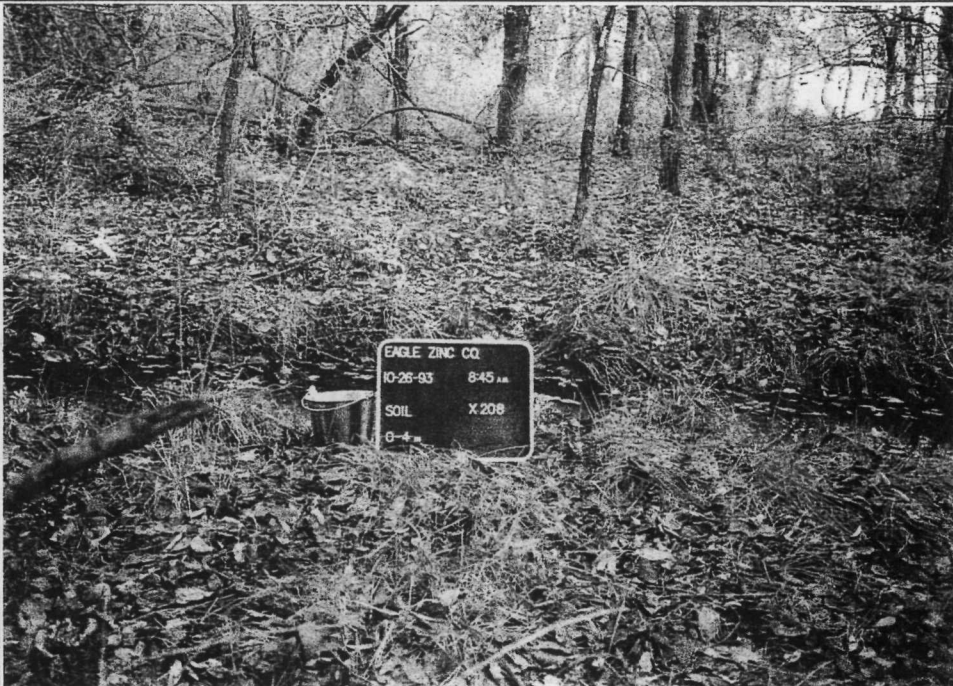
COMMENTS: Picture taken toward: WEST	
Sample X 208	
Sediment sample	
near point at which stream empties into	
Lake Hillsboro.	
Depth 0-4 in	
Roll 1, Photo 1

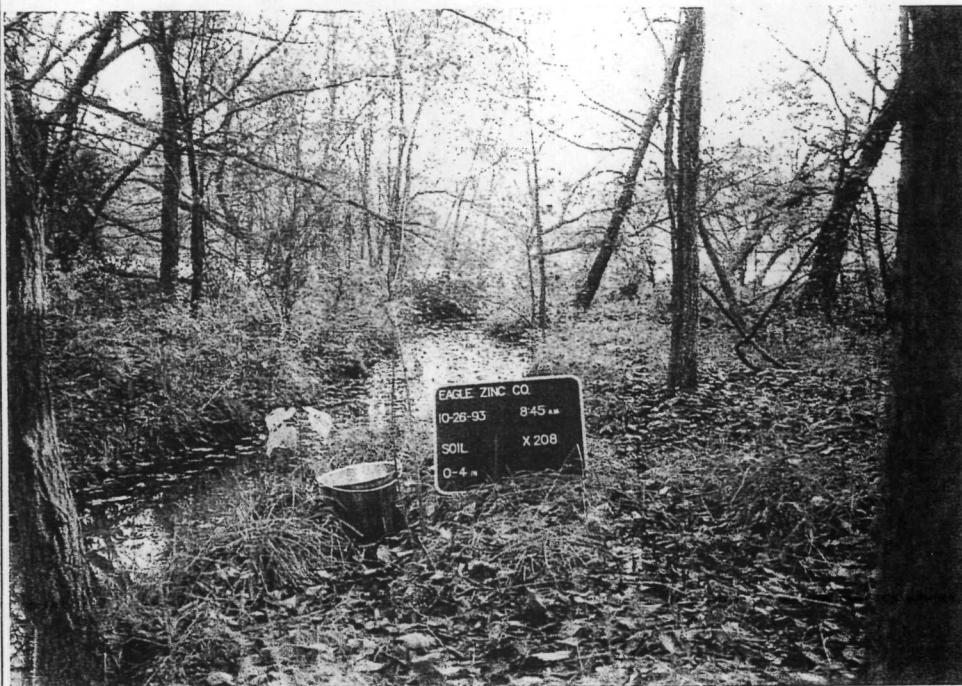
DATE: 10/26/93
TIME: 8:45 A
PHOTOGRAPH TAKEN BY: MARK WAGNER
COMMENTS: Picture taken toward: NORTH
Sample X 208
Sediment sample.
Lake Hillsboro in the background.
Depth 0-4 in
Roll 1, Photo 2

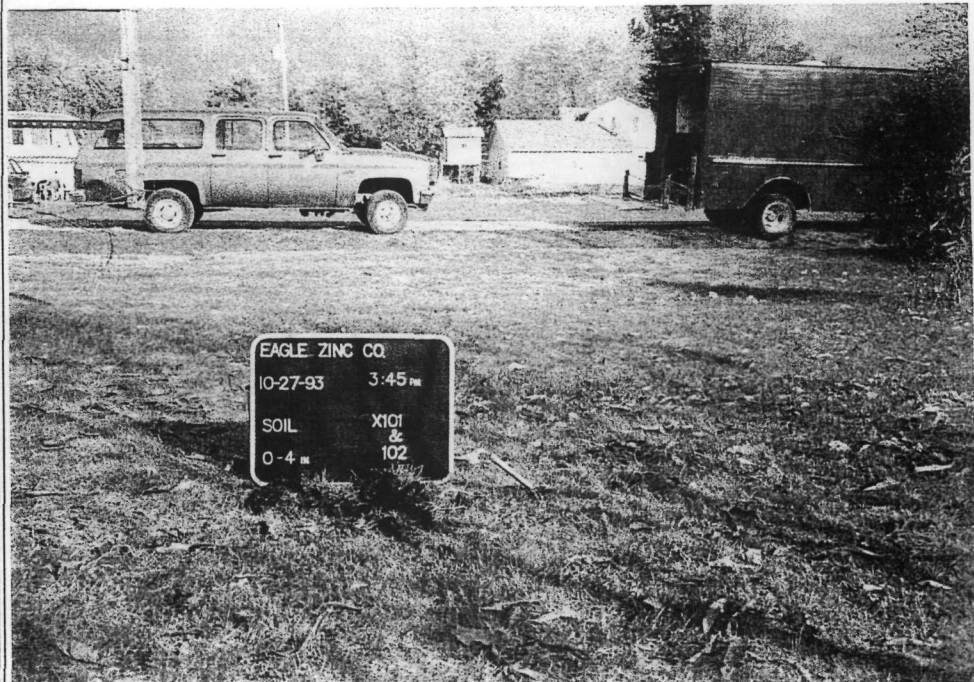
DATE: 10/27/93
TIME: 3:45 P
PHOTOGRAPH TAKEN BY: MARK WAGNER
COMMENTS: Picture taken toward: EAST
Sample X101\X102
(Dup. of X101)
Background soil sample.
Depth 0-4 in
Roll 5, Photo 7

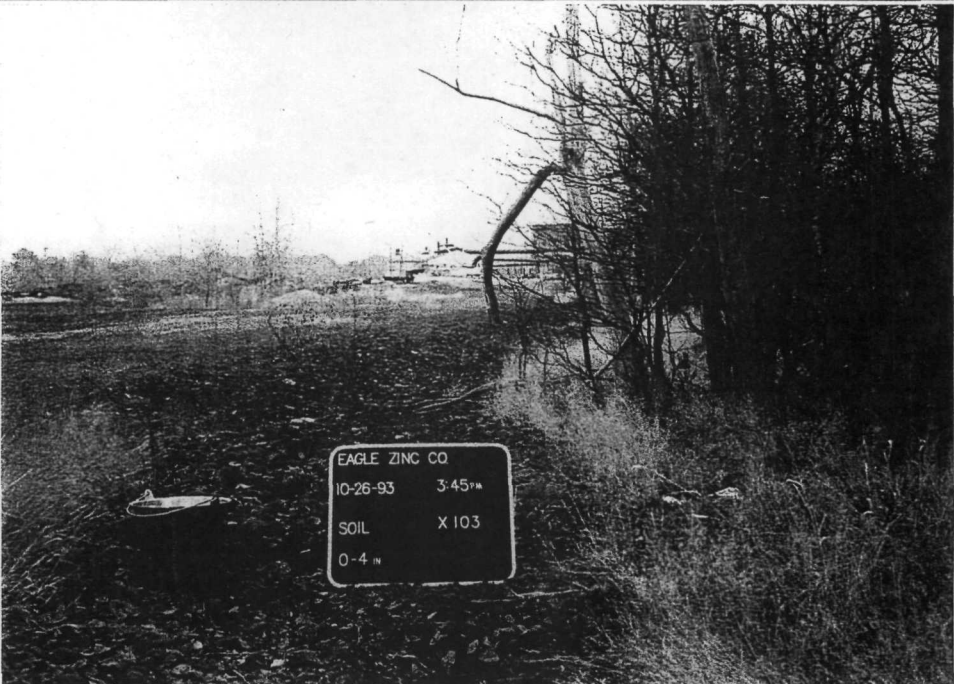
The area on the northwest corner of the property contained furnace residue spread over the soil. Several borings were taken with a stainless steel hand auger and found residue greater than three inches in depth. One residue sample, X103, was collected in the northwest portion of the property. Currently the area of waste pile is unknown. Although all areas of the facility where furnace residue had been deposited, including facility roads, can be classified as a waste pile source.

COMMENTS: Picture taken toward: SOUTHEAST	
Sample X103	
Soil sample taken on the northwest portion of the site	
Depth 0-4 in	
Roll 2, Photo 9

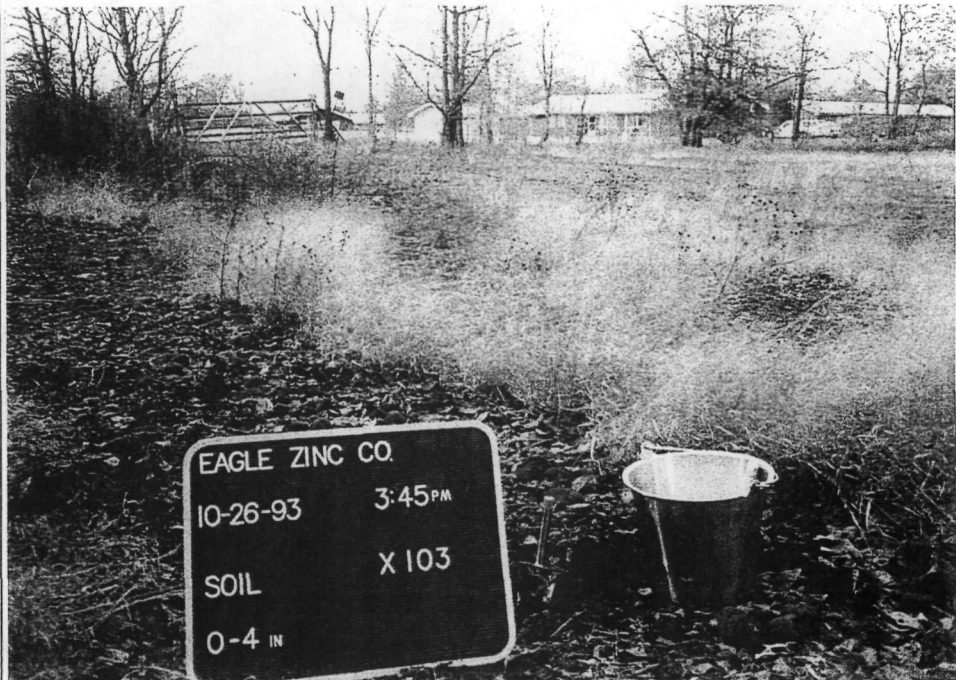
DATE: 10/26/93
TIME: 3:45 P
PHOTOGRAPH TAKEN BY: MARK WAGNER
COMMENTS: Picture taken toward: WEST
Sample X103
Soil sample. Residences in background.
Depth 0-4 in
Roll 2, Photo 10

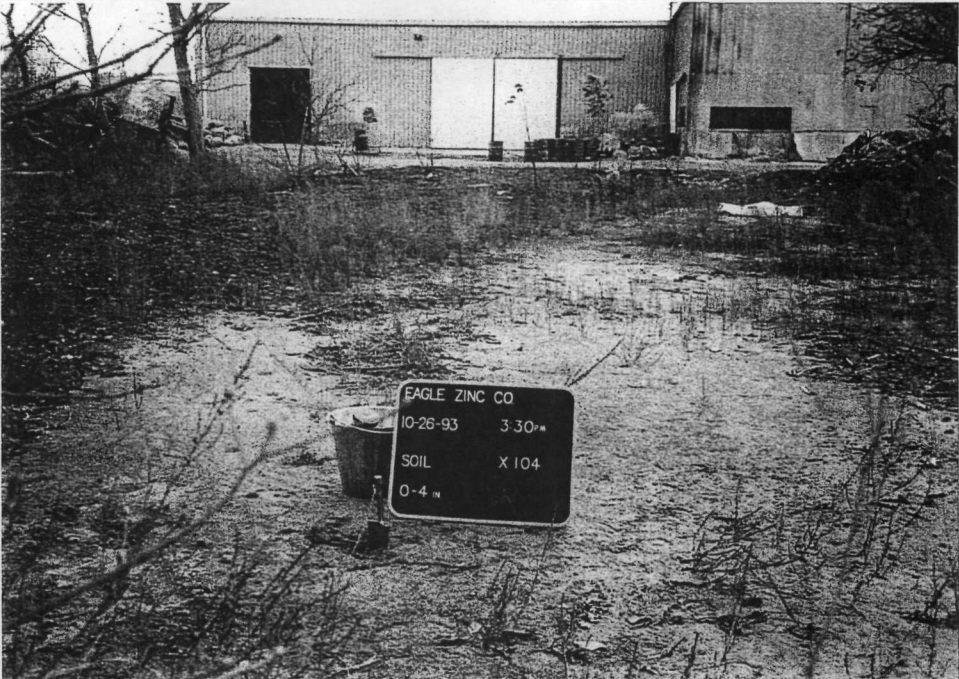
Sample X104 was the only soil sample collected during the field inspection at the facility. Inorganic contaminants found in the soil were similar to those found in the residue piles. Currently the extent of contaminated soil was delineated by analysis of samples collected from residential properties surrounding the zinc facility. Contaminants which exceeded three times background concentrations established the area of contaminated soil (Appendix A). Metals found in significant concentrations included: cadmium, copper and zinc. Contaminants found in residential soils support a release to the air pathway.

COMMENTS: Picture taken toward: SOUTH	
Sample X104	
Soil sample north of the Eagle Zinc "Zebra" building.	
Depth 0-4 in	
Roll 2, Photo 5

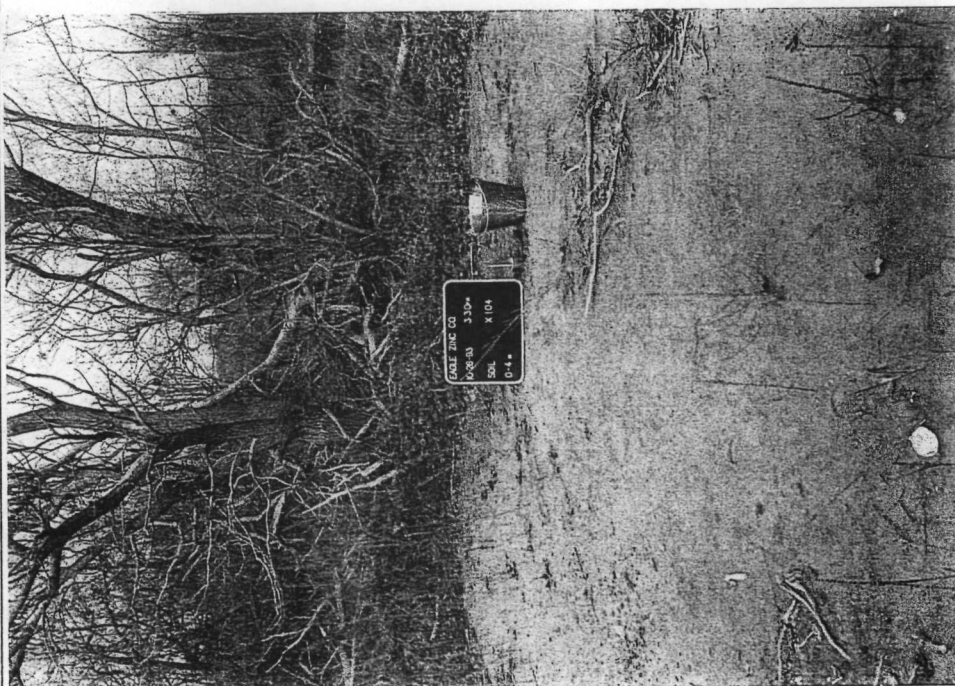
DATE: 10/26/93
TIME: 3:30 P
PHOTOGRAPH TAKEN BY: MARK WAGNER
COMMENTS: Picture taken toward: NORTH
Sample X104
Soil sample. Note stressed vegetation
Depth 0-4 in
Roll 2, Photo 6

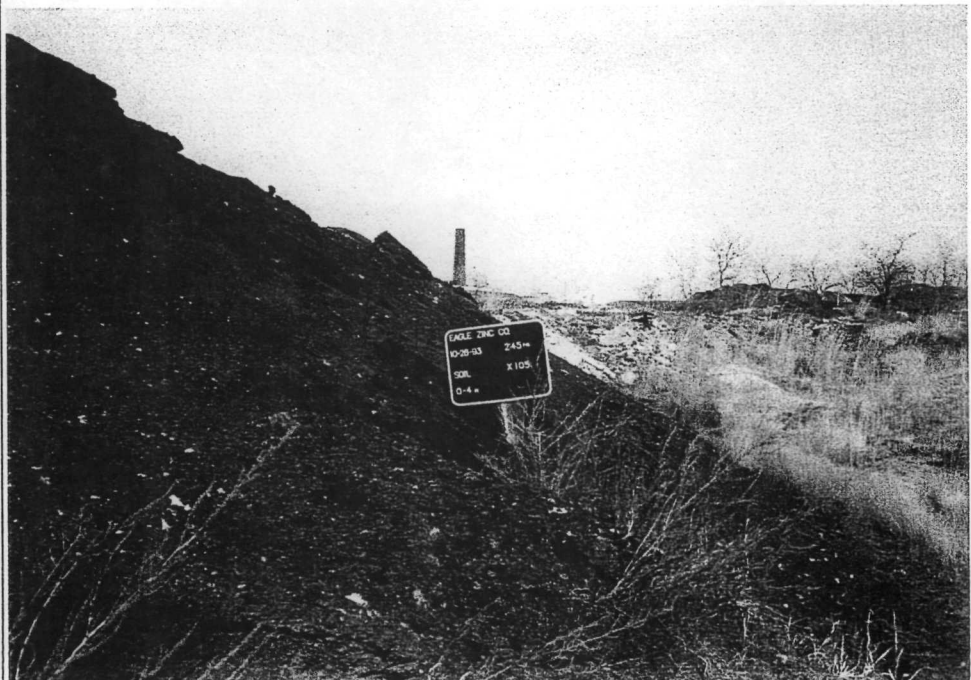
The residue piles were located on the southwest portion of the property. Furnace residues were deposited in such a way as to construct a dam and create the pond on the property. Height of the dam measured 41 feet above existing topography. According to Mr. Tom Youngless, and based on aerial photographs, the dam constructed of residue had been there since the 1950's. Additional residue piles were located further east of the dam, closer to Eagle Zinc buildings. An estimated 10 acres of residue piles were observed on the property during the field inspection and review of aerial photographs. Smaller piles of residue were found north and west of the zinc production facility.

DATE: 10/26/93
TIME: 2:45 P
PHOTOGRAPH TAKEN BY: MARK WAGNER
COMMENTS: Picture taken toward: NORTHEAST
Sample X105
Sample from residue
pile on SW portion
of site. Zinc plant
in background.
Depth 0-4 in
Roll 2, Photo 4

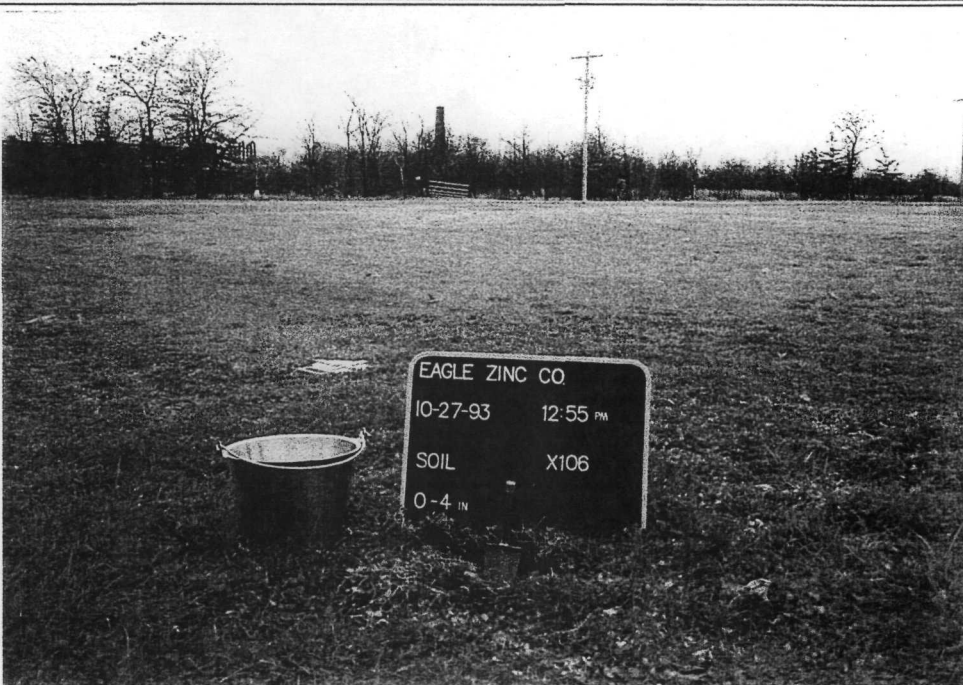
COMMENTS: Picture taken toward: SOUTHEAST	
Sample X106	
Residential soil sample.	
Depth 0-4 in	
Roll 5, Photo 2

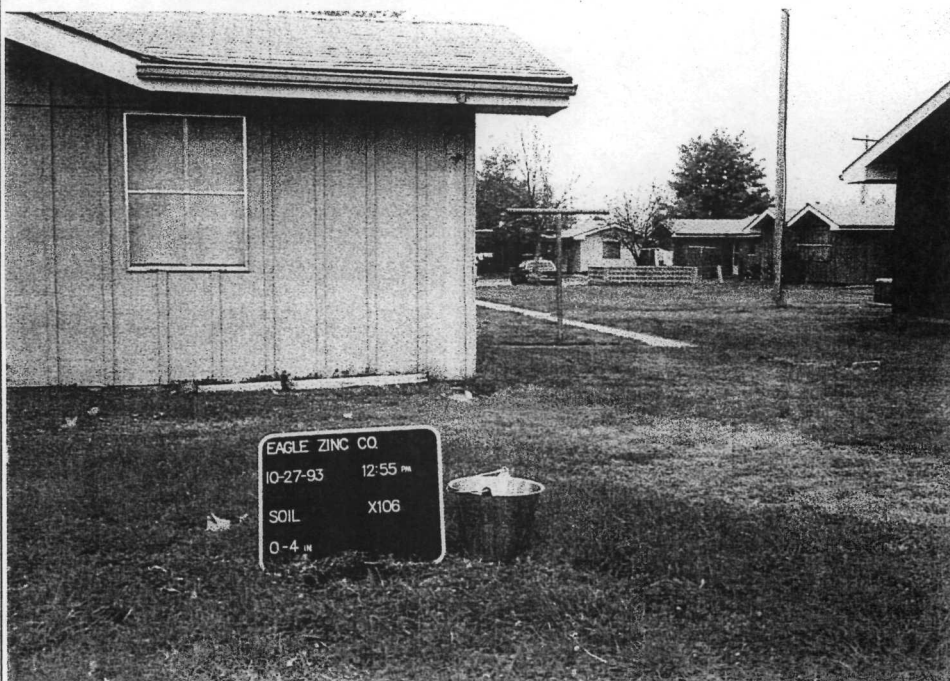
DATE: 10/27/93
TIME: 12:55 P
PHOTOGRAPH TAKEN BY: MARK WAGNER
COMMENTS: Picture taken toward: NORTH
Sample X106
Residential soil sample.
Depth 0-4 in
Roll 5, Photo 3

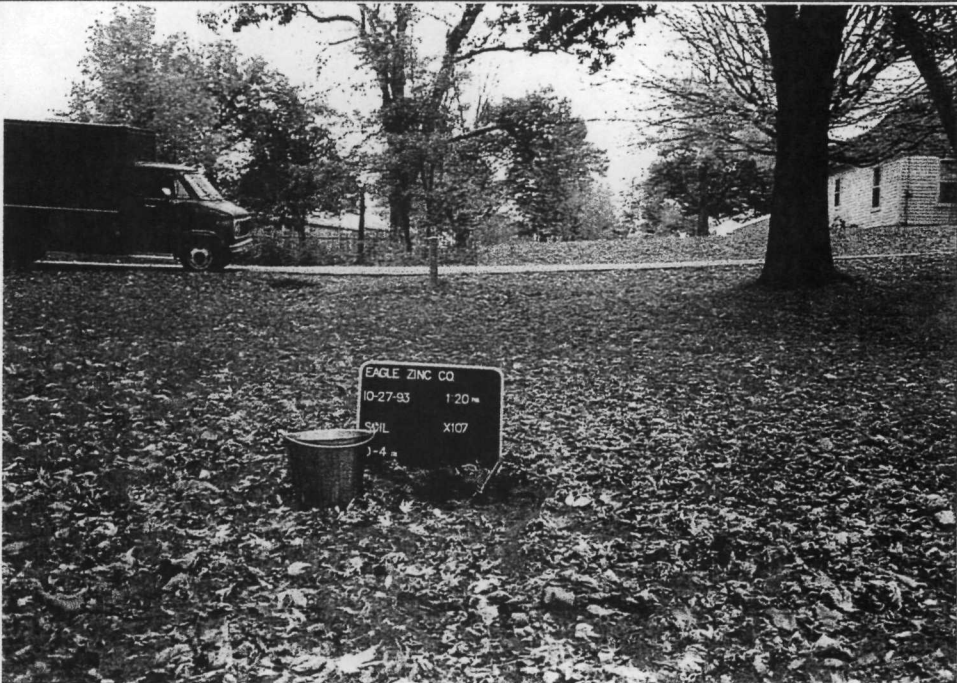
COMMENTS: Picture taken toward: EAST	
Sample X107	
Residential soil sample.	
Depth 0-4 in	
Roll 5, Photo 4

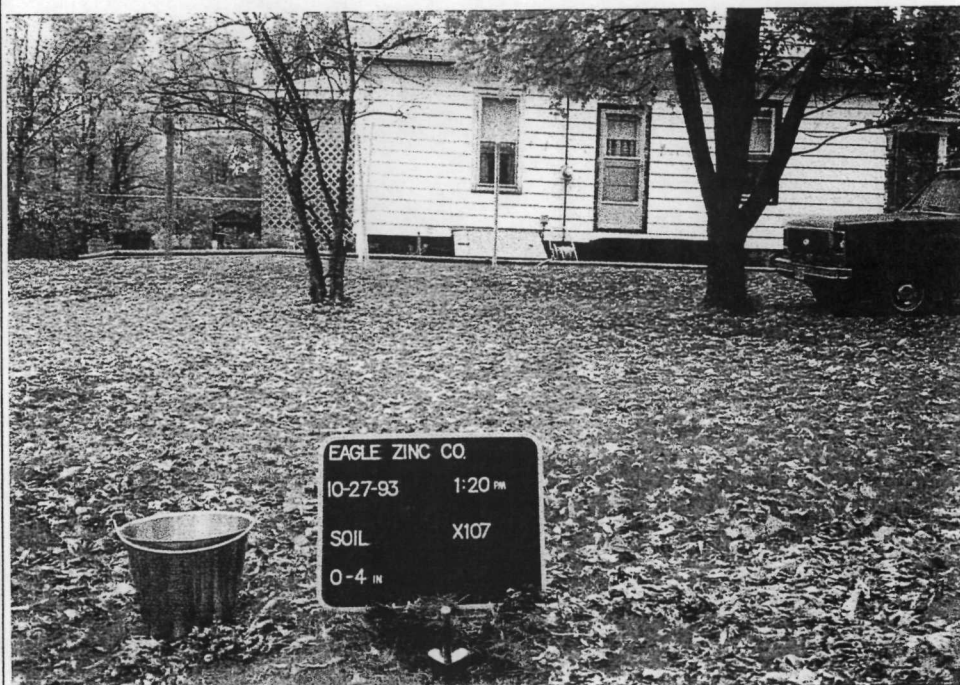
DATE: 10/27/93
TIME: 1:20 P
PHOTOGRAPH TAKEN BY: MARK WAGNER
COMMENTS: Picture taken toward: NORTH
Sample X107
Residential soil sample.
Depth 0-4 in
Roll 5, Photo 5

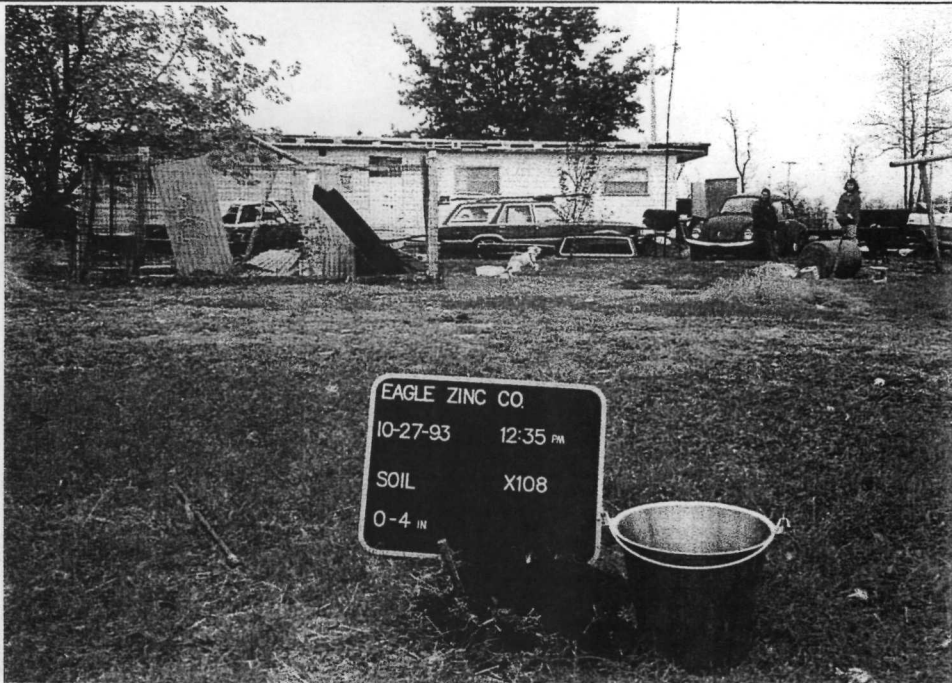
COMMENTS: Picture taken toward: NORTH	
Sample X108	
Residential soil sample.	
Depth 0-4 in	
Roll 4, Photo 11

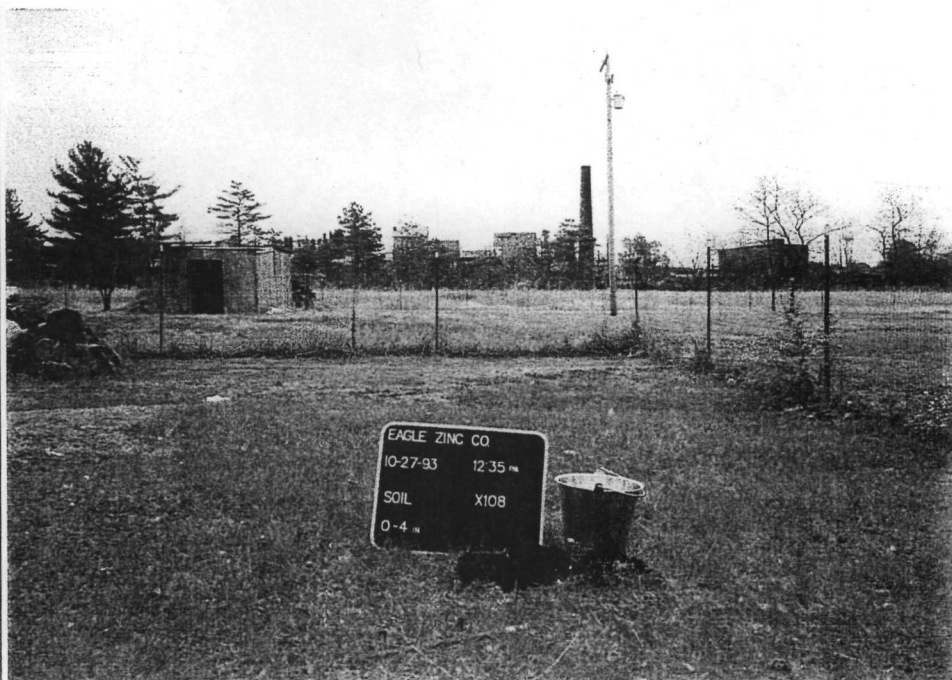
DATE: 10/27/93
TIME: 12:35 P
PHOTOGRAPH TAKEN BY: MARK WAGNER
COMMENTS: Picture taken toward: EAST
Sample X108
Residential soil sample.
Depth 0-4 in
Roll 4, Photo 12

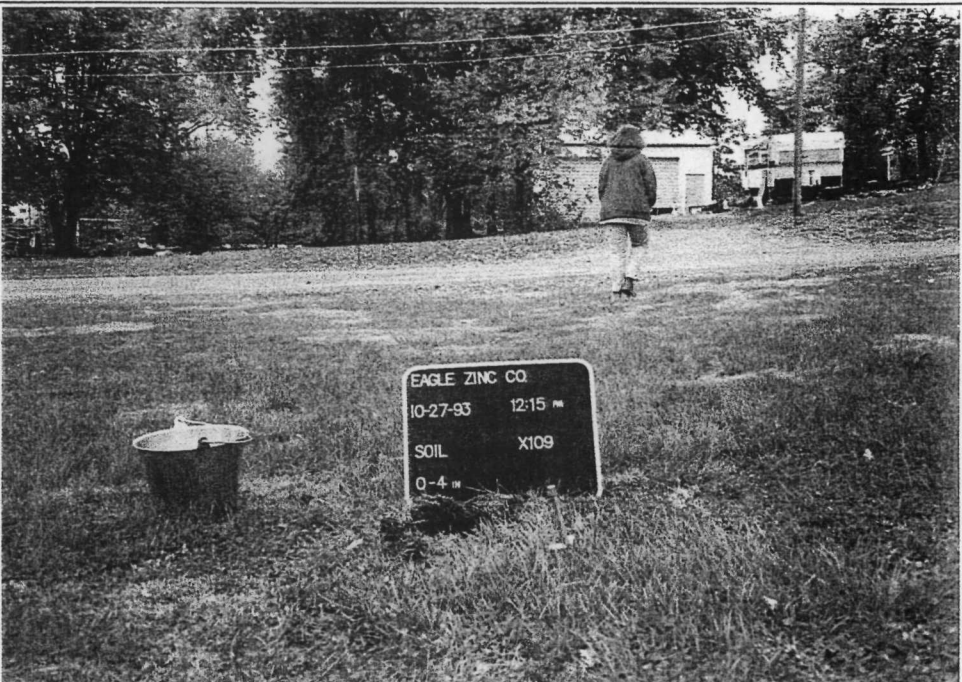
COMMENTS: Picture taken toward: WEST	
Sample X109	
Residential soil sample.	
Depth 0-4 in	
Roll 4, Photo 9

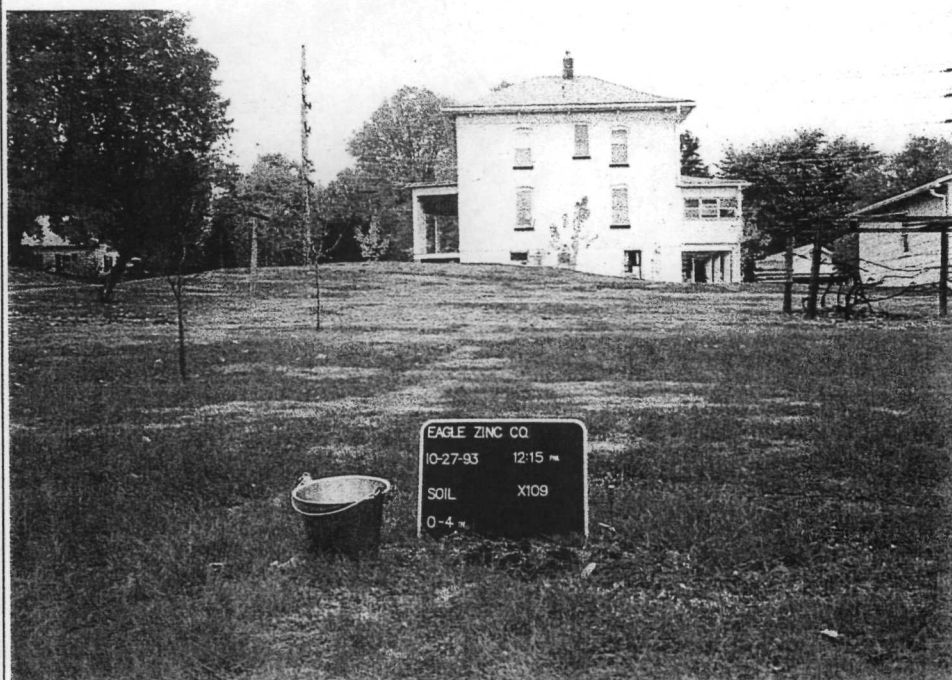
DATE: 10/27/93
TIME: 12:15 P
PHOTOGRAPH TAKEN BY: MARK WAGNER
COMMENTS: Picture taken toward: NORTH
Sample X109
Residential soil sample.
Depth 0-4 in
Roll 4, Photo 10

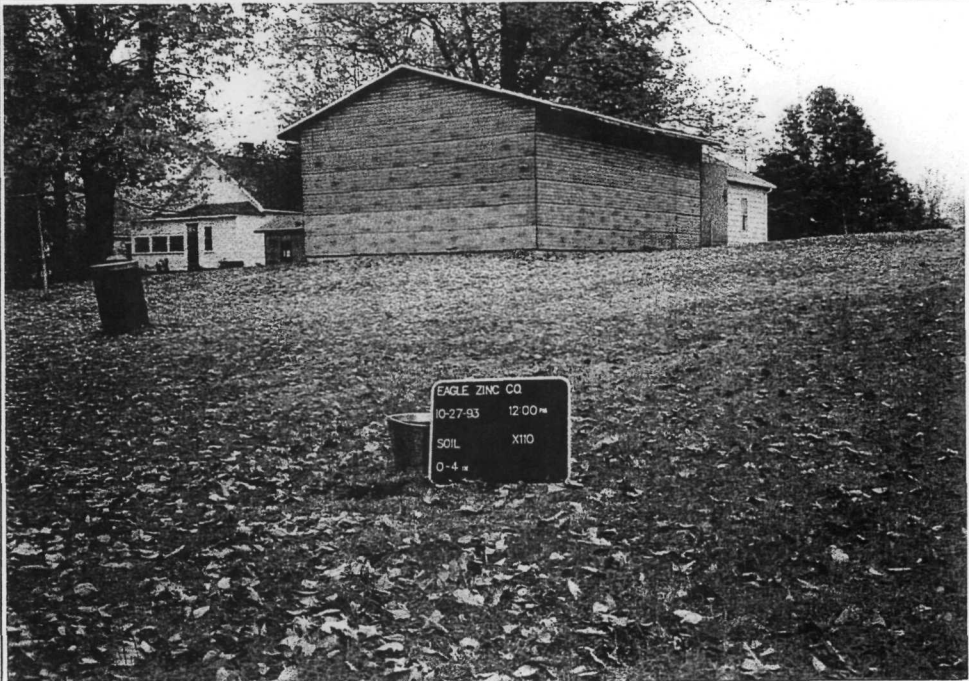
COMMENTS: Picture taken toward: NORTHWEST	
Sample X110	
Residential soil sample.	
Depth 0-4 in	
Roll 4, Photo 7

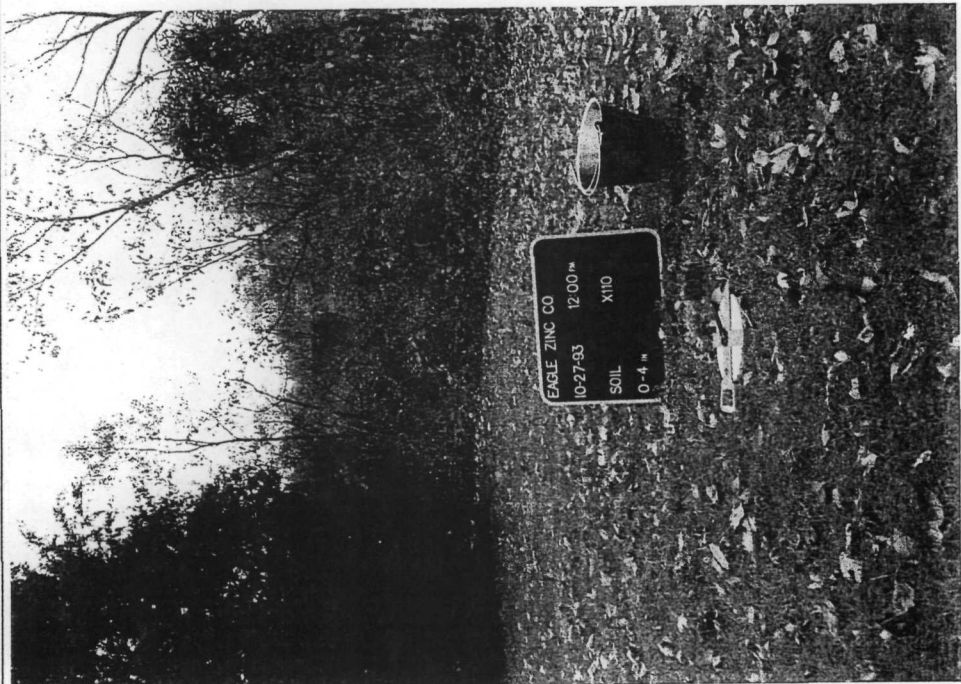
DATE: 10/27/93
TIME: 12:00 P
PHOTOGRAPH TAKEN BY: MARK WAGNER
COMMENTS: Picture taken toward: SOUTHEAST
Sample X110
Residential soil sample. Zinc residue pile directly behind photo board.
Depth 0-4 in
Roll 4, Photo 8

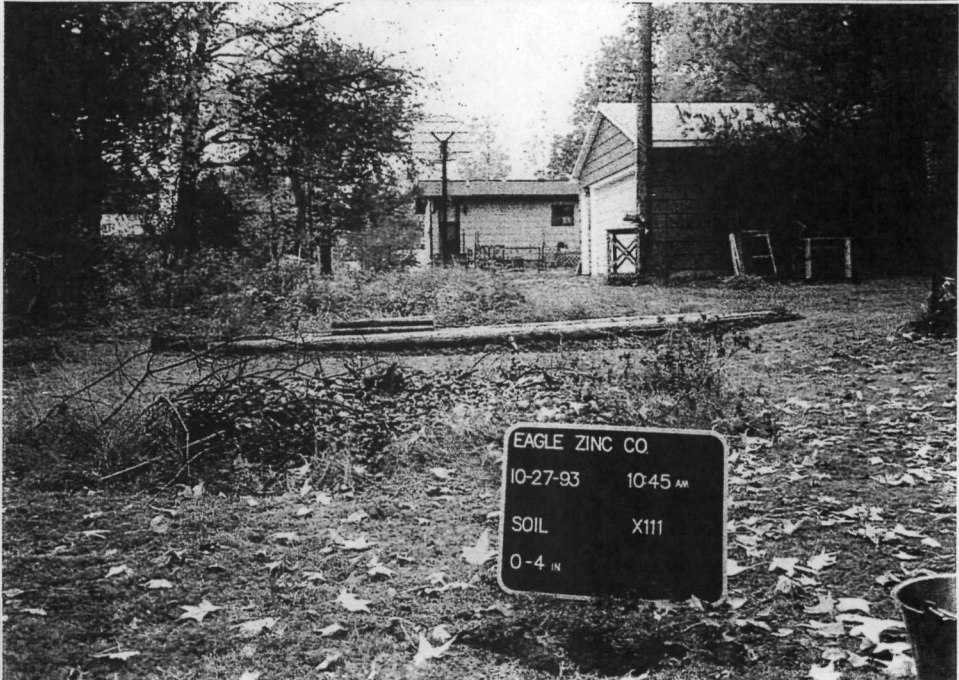
COMMENTS: Picture taken toward: SOUTH	
Sample X111	
Residential soil sample.	
Depth 0-4 in	
Roll 4, Photo 5
